## Claymont Avenue Sewer Repair Baltimore, MD

### PROJECT INFORMATION - 454

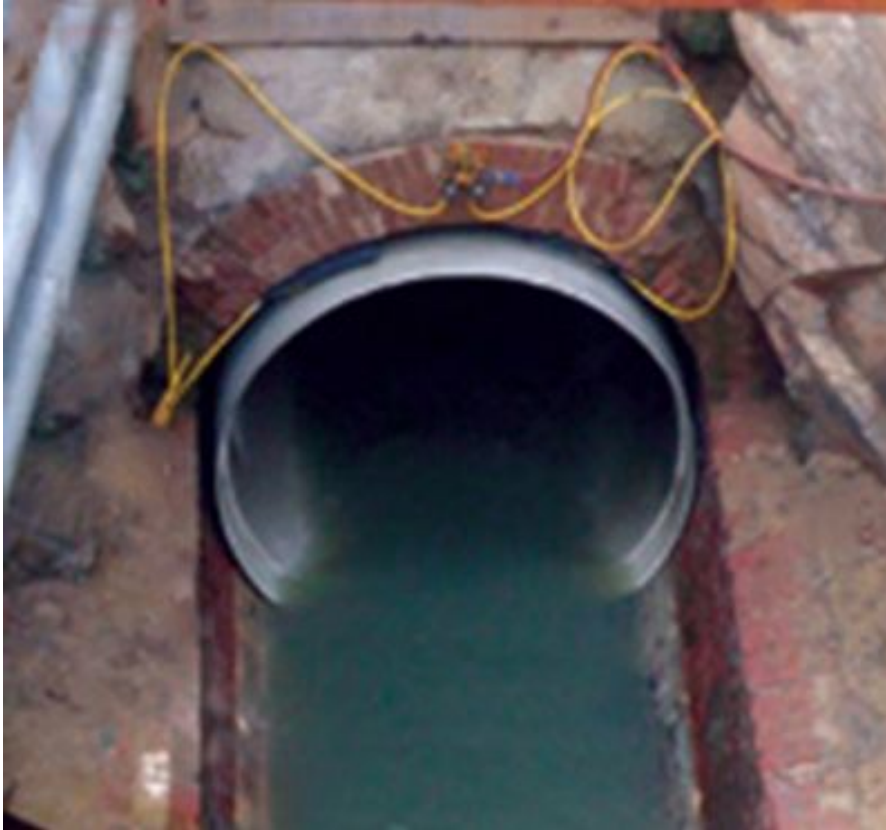
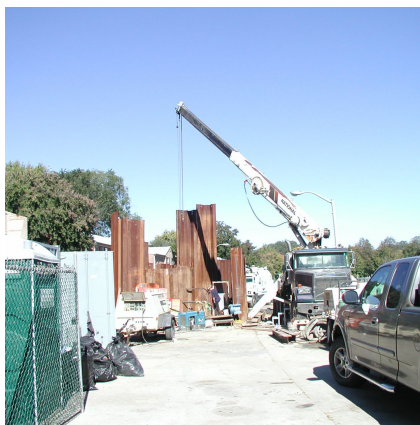
Bradshaw Construction was contracted by Baltimore city to perform an emergency repair and rehabilitation of a collapsed brick sewer causing sewage back-up and flooding in a residential area. Bradshaw excavated down and removed the damaged portion along with the top of the sewer. Then, 30" PVC slip-lining pipe was inserted into the sewer and pushed along the existing pipeline. When the entire length of slip-line pipe was installed the space between the new PVC pipe and the old deteriorated brick sewer was pumped full of grout so as to fill any voids. The major challenge of this project was that all the work needed to be completed without further restriction of the active sanitary sewer.
